## Wind Mitigation Inspection

### Spoonbill Courtyard

501,503,505,507,509 Sanderling Cir  
Bradenton FL, 34209

05/21/2019

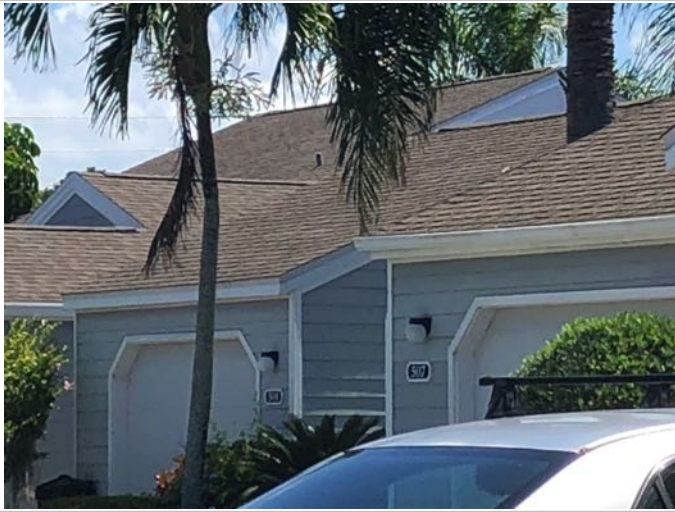
Roof Covering

| 2.1 Roof Covering Type: | Permit Application Date | FBC or MDC Product Approval # | Year of Original Installation or Replacement | No Information Provided for Compliance |
|---|---|---|---|---|
| <input checked="" type="checkbox"/> 1. Asphalt/Fiberglass Shingle | 3 21 11 | | | <input type="checkbox"/> |

- ☒ A. All roof coverings listed above meet the FBC with a FBC or Miami-Dade Product Approval listing current at time of installation OR have a roofing permit application date on or after 3/1/02 OR the roof is original and built in 2004 or later.

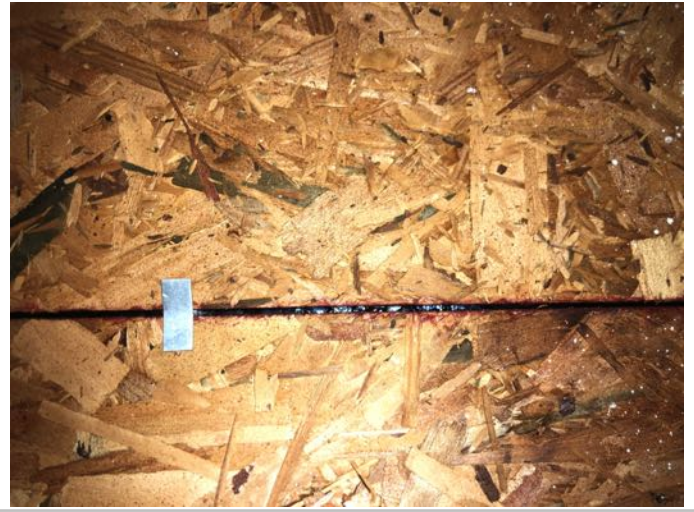
SWR/Decking

- ☒ A. SWR (also called Sealed Roof Deck) Self-adhering polymer modified-bitumen roofing underlayment applied directly to the sheathing or foam adhesive SWR barrier (not foamed-on insulation) applied as a supplemental means to protect the dwelling from water intrusion in the event of roof covering loss.
- ☐ B. No SWR.
- ☐ C. Unknown or undetermined.

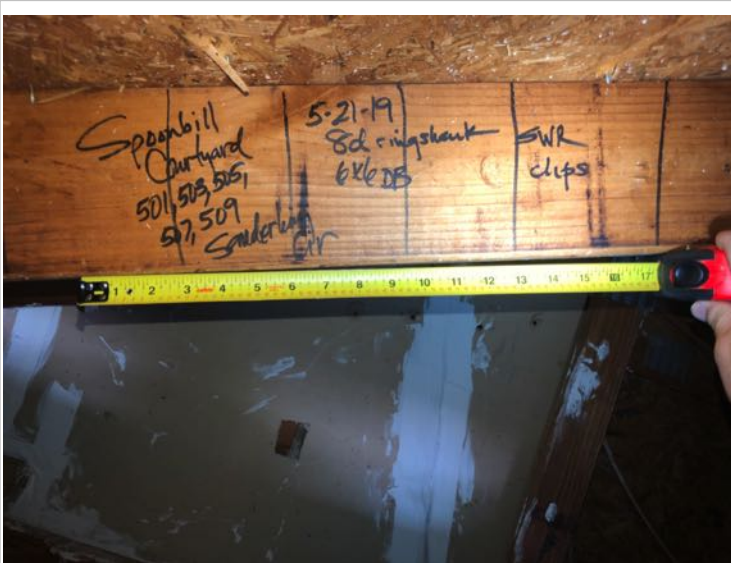
Spacing

- ☒ C. Plywood/OSB roof sheathing with a minimum thickness of 7/16" inch attached to the roof truss/rafter (spaced a maximum of 24" inches o.c.) by 8d common nails spaced a maximum of 6" inches in the field. -OR- Dimensional lumber/Tongue & Groove decking with a minimum of 2 nails per board (or 1 nail per board if each board is equal to or less than 6 inches in width). -OR- Any system of screws, nails, adhesives, other deck fastening system or truss/rafter spacing that is shown to have an equivalent

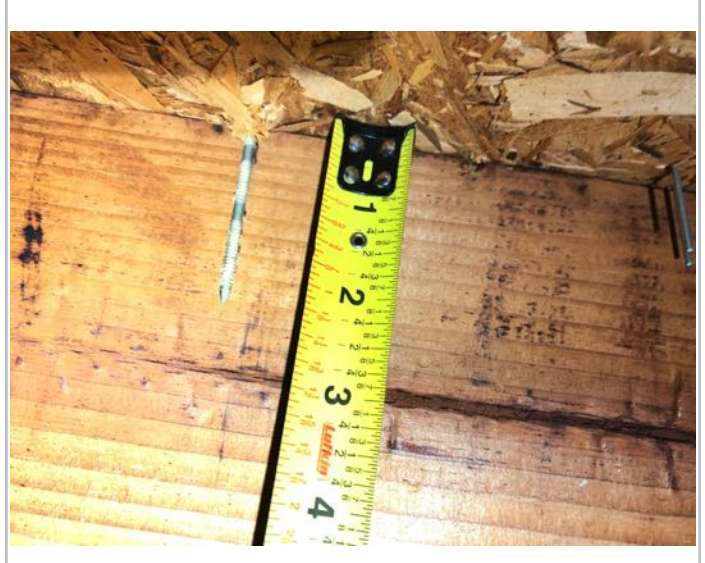
8d Nails

or greater resistance than 8d common nails spaced a maximum of 6 inches in the field or has a mean uplift resistance of at least 182 psf.
