## Wind Mitigation Inspection

### Spoonbill Courtyard

501,503,505,507,509 Woodstork Cir  
Bradenton FL, 34209

05/21/2019

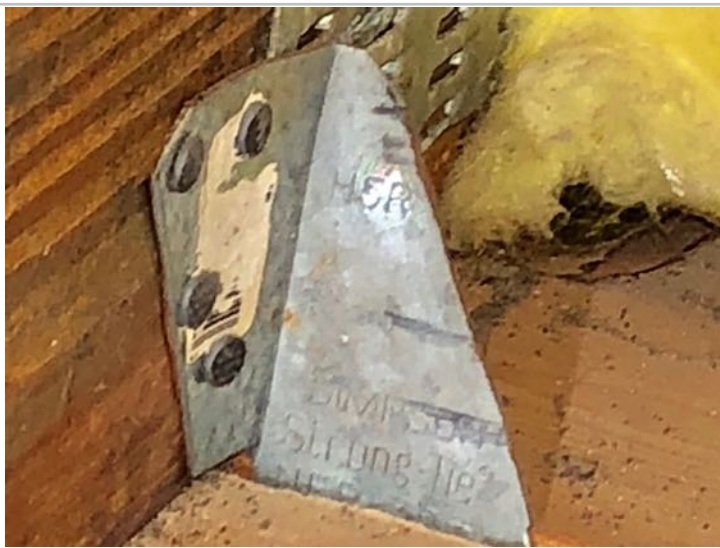
Clip

- ☒ Secured to truss/rafter with a minimum of three (3) nails, **and**
- ☒ Attached to the wall top plate of the wall framing, or embedded in the bond beam, with less than a ½" gap from the blocking or truss/rafter **and** blocked no more than 1.5" of the truss/rafter, **and** free of visible severe corrosion.
- ☒ B. Clips
  - ☒ Metal connectors that do not wrap over the top of the truss/rafter, **or**
  - ☐ Metal connectors with a minimum of 1 strap that wraps over the top of the truss/rafter and does not meet the nail position requirements of C or D, but is secured with a minimum of 3 nails.
- ☐ C. Single Wraps
