## Wind Mitigation Inspection

### Spoonbill Courtyard

510,512,514,516,518,520 Woodstork Cir  
Bradenton FL, 34209

# Uniform Mitigation Verification Inspection Form

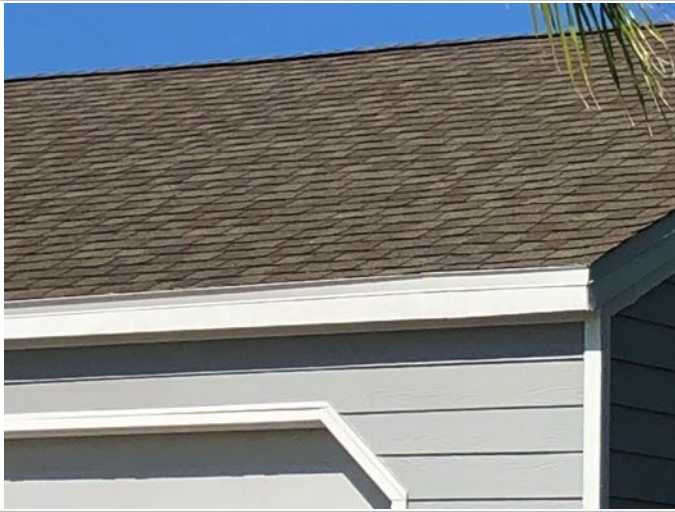
Roof Covering

| 2.1 Roof Covering Type: | Permit Application Date | FBC or MDC Product Approval # | Year of Original Installation or Replacement | No Information Provided for Compliance |
|---|---|---|---|---|
| <input checked="" type="checkbox"/> 1. Asphalt/Fiberglass Shingle | 3 3 11/ | | | <input type="checkbox"/> |

- ☒ A. All roof coverings listed above meet the FBC with a FBC or Miami-Dade Product Approval listing current at time of installation OR have a roofing permit application date on or after 3/1/02 OR the roof is original and built in 2004 or later.
