## Wind Mitigation Inspection

### Spoonbill Courtyard

511,513,515,517,519 Woodstork Cir  
Bradenton FL, 34209

05/21/2019

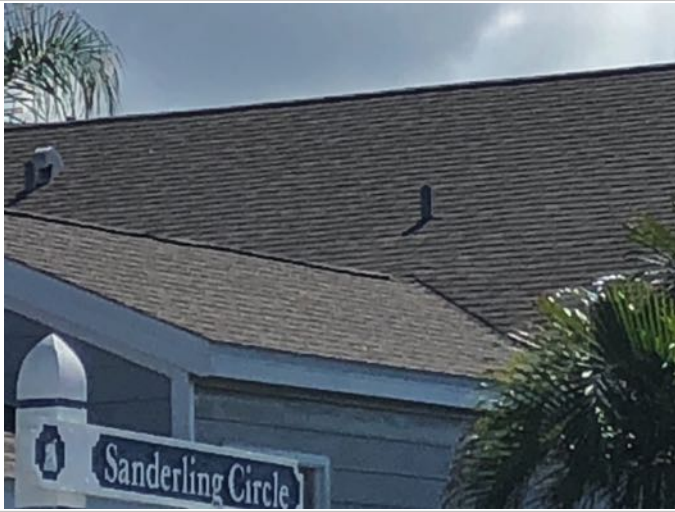
Roof Covering

| 2.1 Roof Covering Type: | Permit Application Date | FBC or MDC Product Approval # | Year of Original Installation or Replacement | No Information Provided for Compliance |
|---|---|---|---|---|
| <input checked="" type="checkbox"/> 1. Asphalt/Fiberglass Shingle | 3 15 11 | | | <input type="checkbox"/> |

- ☒ A. All roof coverings listed above meet the FBC with a FBC or Miami-Dade Product Approval listing current at time of installation OR have a roofing permit application date on or after 3/1/02 OR the roof is original and built in 2004 or later.

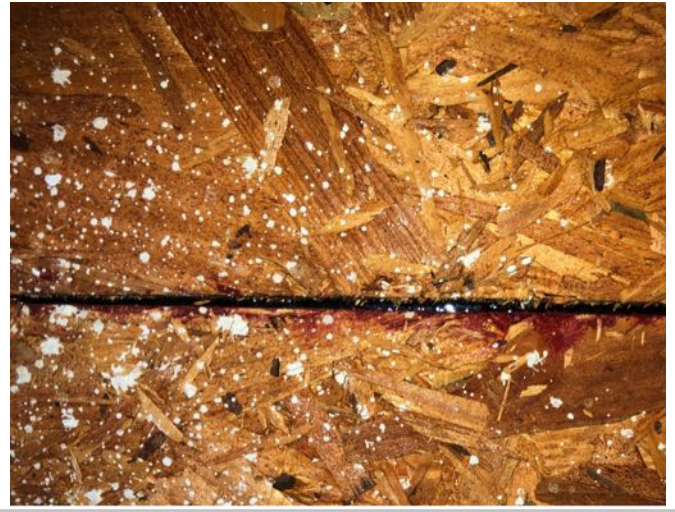
SWR/Decking

- ☒ C. Plywood/OSB roof sheathing with a minimum thickness of 7/16" inch attached to the roof truss/rafter (spaced a maximum of 24" inches o.c.) by 8d common nails spaced a maximum of 6" inches in the field. -OR- Dimensional lumber/Tongue & Groove decking with a minimum of 2 nails per board (or 1 nail per board if each board is equal to or less than 6 inches in width). -OR- Any system of screws, nails, adhesives, other deck fastening system or truss/rafter spacing that is shown to have an equivalent

- ☒ A. SWR (also called Sealed Roof Deck) Self-adhering polymer modified-bitumen roofing underlayment applied directly to the sheathing or foam adhesive SWR barrier (not foamed-on insulation) applied as a supplemental means to protect the dwelling from water intrusion in the event of roof covering loss.
- ☐ B. No SWR.
- ☐ C. Unknown or undetermined.

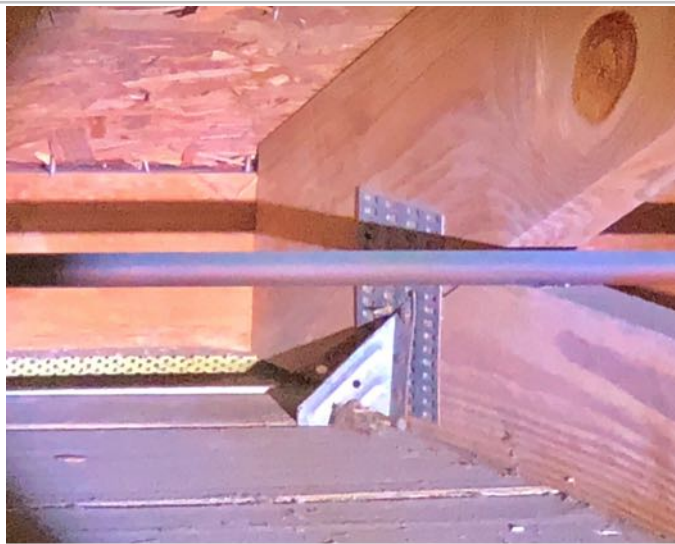
Clip

- ☒ Secured to truss/rafter with a minimum of three (3) nails, **and**
- ☒ Attached to the wall top plate of the wall framing, or embedded in the bond beam, with less than a ½" gap from the blocking or truss/rafter **and** blocked no more than 1.5" of the truss/rafter, **and** free of visible severe corrosion.
- ☒ B. Clips
  - ☒ Metal connectors that do not wrap over the top of the truss/rafter, **or**
  - ☐ Metal connectors with a minimum of 1 strap that wraps over the top of the truss/rafter and does not meet the nail position requirements of C or D, but is secured with a minimum of 3 nails.
- ☐ C. Single Wraps

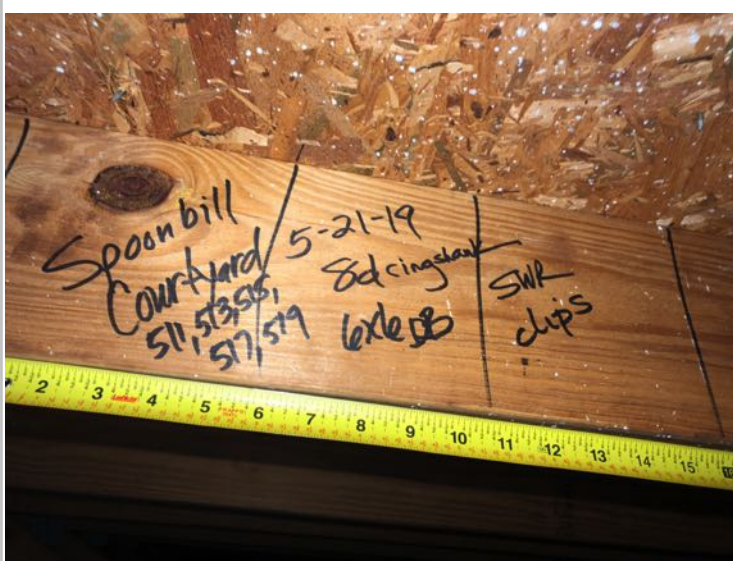
Spacing

or greater resistance than 8d common nails spaced a maximum of 6 inches in the field or has a mean uplift resistance of at least 182 psf.
